Field Evaluation of Ozone for Control of Corrosion and Scale in a Zero Blowdown Application

Association of Water Technologies
Fifth Annual Convention
November 18 to 21, 1992

by: Timothy Keister
ProChemTech, Inc.

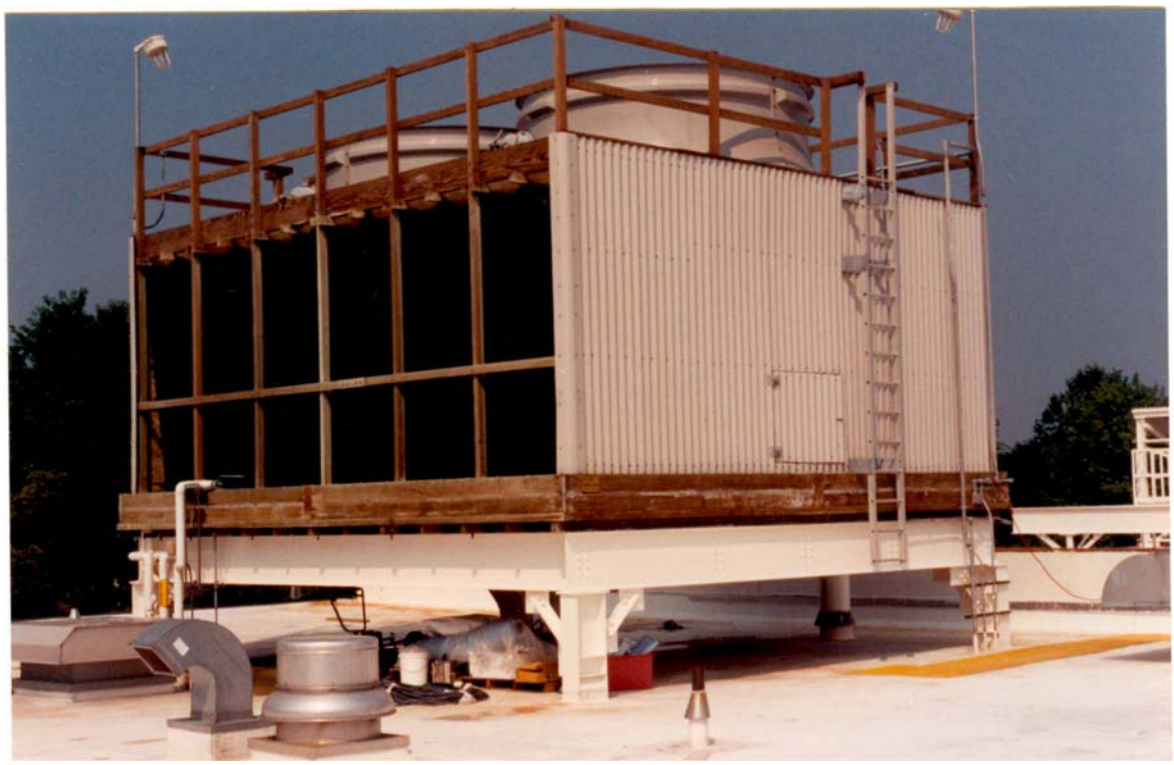
The new cooling system uses the above pictured Marley Company duel cell, induced draft crossflow cooling tower of approximately 1000 tons capacity for evaporative heat rejection. System materials of construction include treated wood, fiberglass, polyvinyl chloride, and galvanized steel in the cooling tower; black iron piping; and yellow metal alloys in the air compressor and chiller served by the system. A steam heated coil constructed of galvanized steel pipe is installed in the cooling tower basin, which serves as the system cold well, for freeze protection.

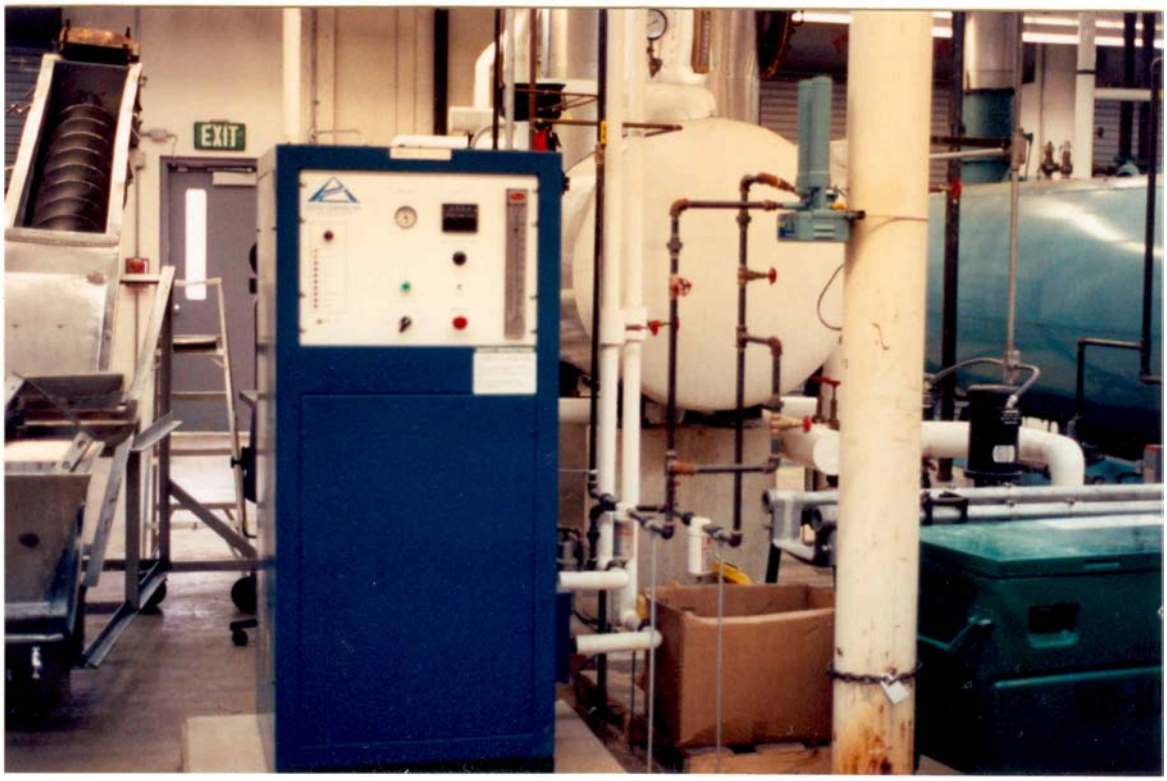
Ozone treatment of the cooling system is supplied by the pictured PCI Ozone and Control Systems Model G 7 ozonator, which is rated 0 to 7 lbs/day of ozone. The unit operates as a side stream device, generated ozone is injected into cooling water passing through the unit. Cost of this unit is reported by the manufacturer to be in the $20,000 range. We did note that several gpm of one pass city water was being used to cool the ozonator as cooling system water was reported to be to warm for such use.

Ozonated water is piped from the ozone generator and discharged directly into the cooling tower basin as shown. A definite ozone odor was present around the cooling tower at all outputs exceeding one lb/day, with plant personnel reporting that the ozone being released into the air during higher outputs was intolerable near the cooling tower.

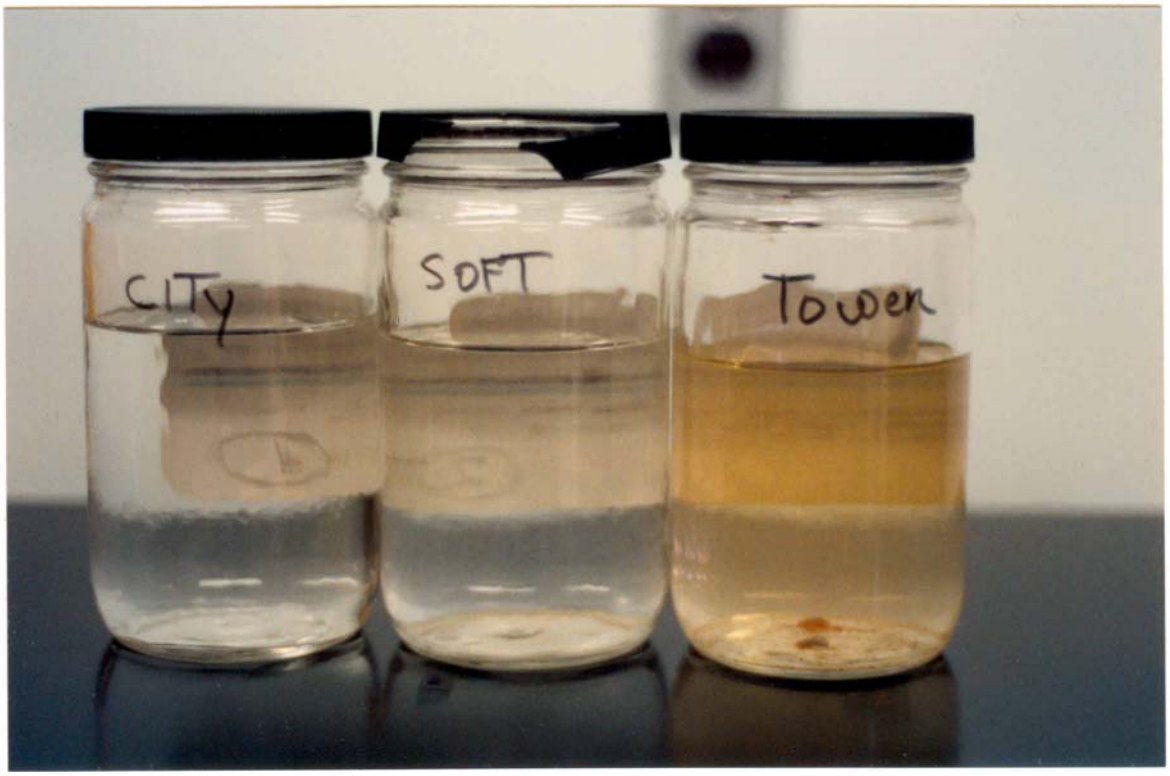
As shown in the preceding photo, the cooling water sample was reddish in color with some red floc present, likely due to the substantial amount of iron in the water. The analysis data clearly indicates that substantial corrosion was taking place within the cooling system prior to the sampling.

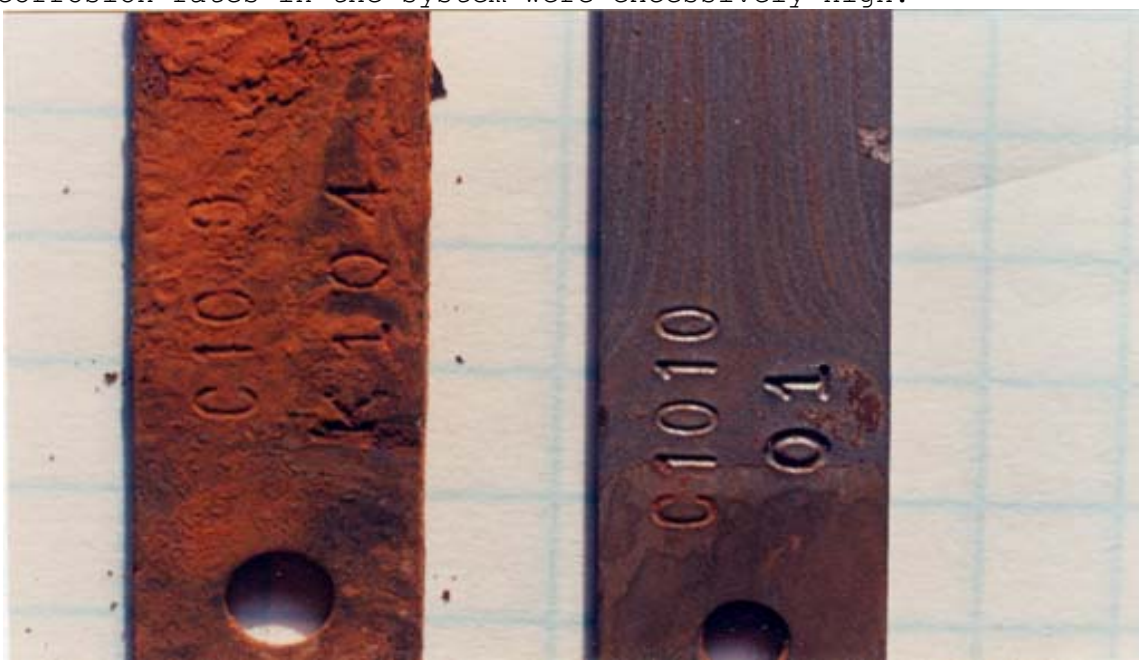
COUPONS FROM OZONE AND CHEMICALLY TREATED SYSTEMS

The previous photo compares a 1010 mild steel corrosion coupon exposed for 30 days in the ozone treated cooling system beside a similar coupon exposed for 60 days in a cooling tower system running high cycles with soft water makeup and a molybdate-silicate chemistry program. Corrosion rate on the ozone treated coupon is 20.57 mil/yr, while the chemically treated coupon showed a rate of 0.29 mil/yr.

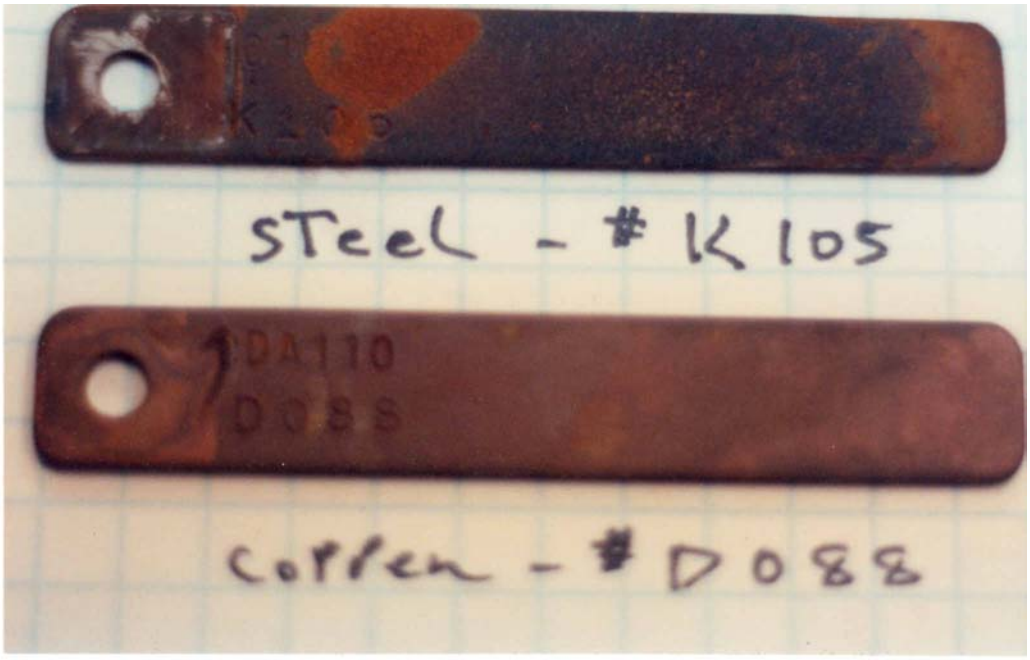
The above third set of corrosion coupons was installed on May 7, 1992, and removed 30 days later on June 7, 1992. Analysis of these corrosion coupons gave the following results.

Coupon Material	Corrosion Rate
1010 mild steel	2.17 mil/yr
CDA 110 copper	0.15 mil/yr

As expected, these results show a substantial decrease in corrosion rate due to use of hard water in the cooling system and resultant operation under scale forming conditions.

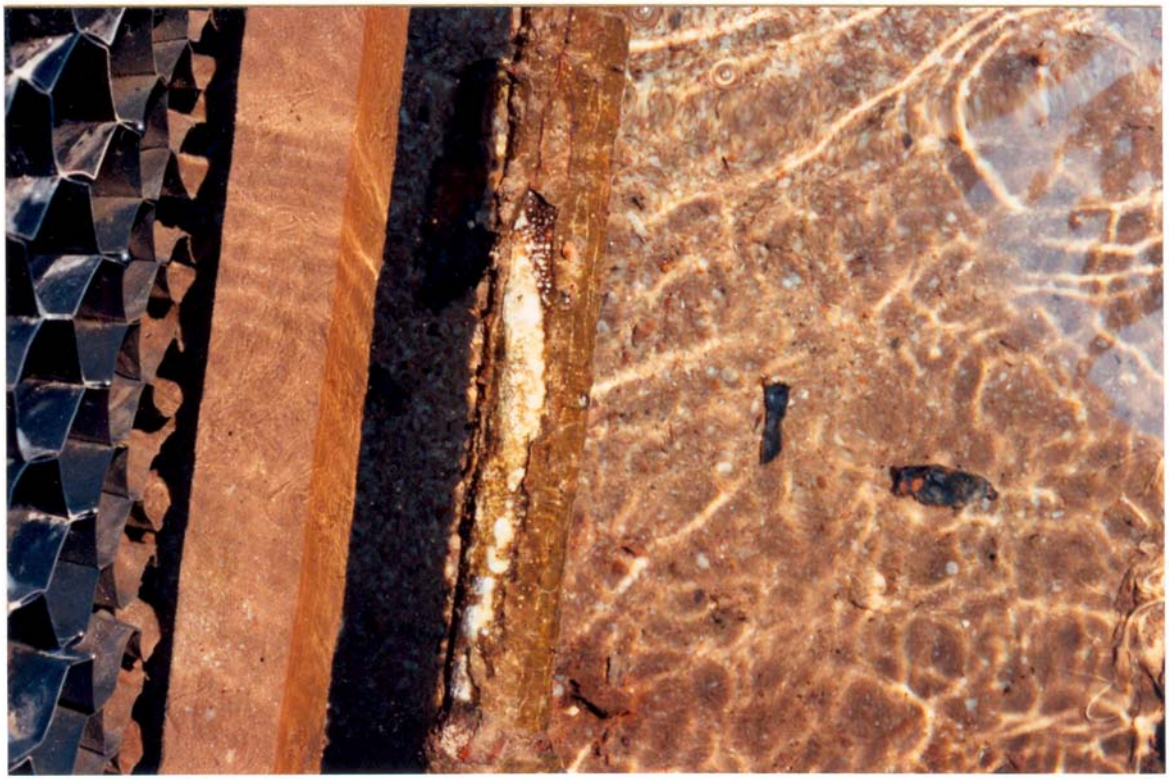
Substantial buildup of scale was noted on the heating coil in the cooling tower basin during this time period. A sample of scale was obtained on July 7, 1992, and analyzed with the following results obtained.

These scale analysis results show that calcium, magnesium, iron, and silicon are present in scale formed from the ozone treated cooling water. Based on the previous corrosion rates, the iron component is believed to result from deposition of corrosion products, while the calcium, magnesium, and silicon are supplied from the makeup water.

As shown by the following photo, the scale is a hard material which adheres to the surface on which it forms. The evident spalling is believed to be due from thermal stress resultant from loss of heat transfer. Active scale formation is evident in those areas where the older scale has spalled off.
